Service Bulletin

Bulletin No.: 10-03-08-001B

Subject: Front Suspension Noise Over Bumps in Cold Weather (Install Revised Front Stabilizer Shaft Insulators)

Models: 2010-2011 Cadillac SRX

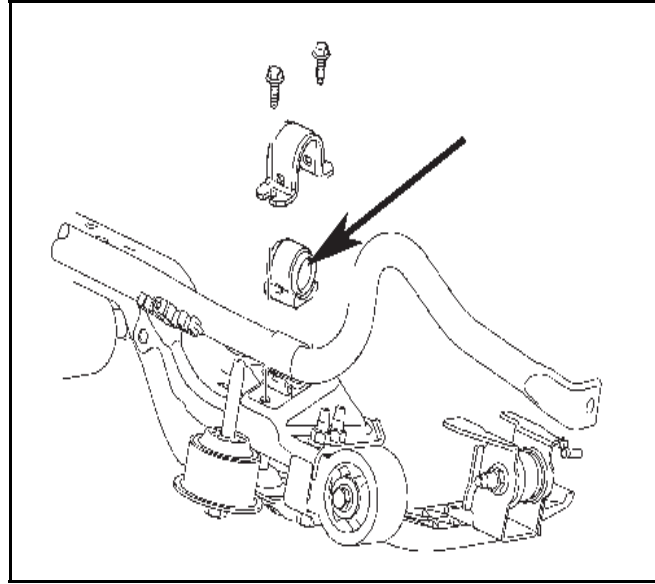
2396869

This condition may be caused by the interface between the front stabilizer shaft and the front stabilizer shaft insulators (bushings).

Remove the left and right front stabilizer insulators (bushings). Refer to Stabilizer Shaft Insulator Replacement in SI. Wipe off the surface of the stabilizer bar to remove any loose rubber or grease residue. Install the revised left and right stabilizer insulators (bushings). For installation instructions, refer to Stabilizer Shaft Insulator Replacement in SI. Install the new service stabilizer insulators (bushings) so that the chamfer edge is facing toward the outside of the vehicle. This will put the slits in the bushing facing opposite directions.
