#PI0285C: Inconsistent Rear Back-Up Camera Operation, Bluetooth Delay, Intermittent Audio Concerns, Blank DVD Display and Various Additional Navigation Radio/Clock Concerns - (Dec 5, 2011)

**Inconsistent Rear Back-Up Camera Operation, Bluetooth Delay,
Subject: Intermittent Audio Concerns, Blank DVD Display and Various Additional
Navigation Radio/Clock Concerns**

Models: 2010-2011 Buick LaCrosse

All Equipped with Navigation Radio RPO UYS

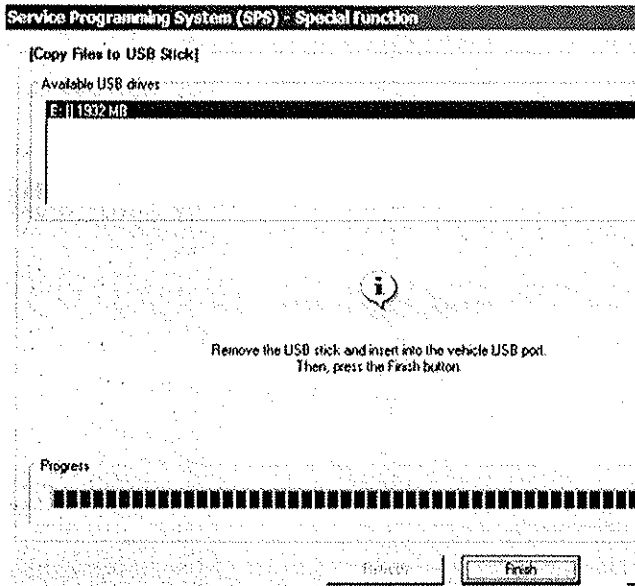
7. Insert a USB flash drive into the USB port of your computer. Press the **REFRESH** button if your USB drive **IS NOT** selectable in the: Available USB Drives box.
8. Select: NEXT, from the SPS Special Function screen.
9. Monitor the: Progress Status bar at the bottom of the SPS Special Function screen.

Note: The files have been successfully loaded onto the USB flash drive when the Progress Status bar is completely shaded and the SPS Special Function screen displays the following message: "Remove the USB stick and insert into the vehicle USB port".
